### **The Aircraft Accident Investigation Bureau of Ethiopia**

Serious Incident

1) Boeing 777-200, ET AQL

2) Airbus A350, ET ATR

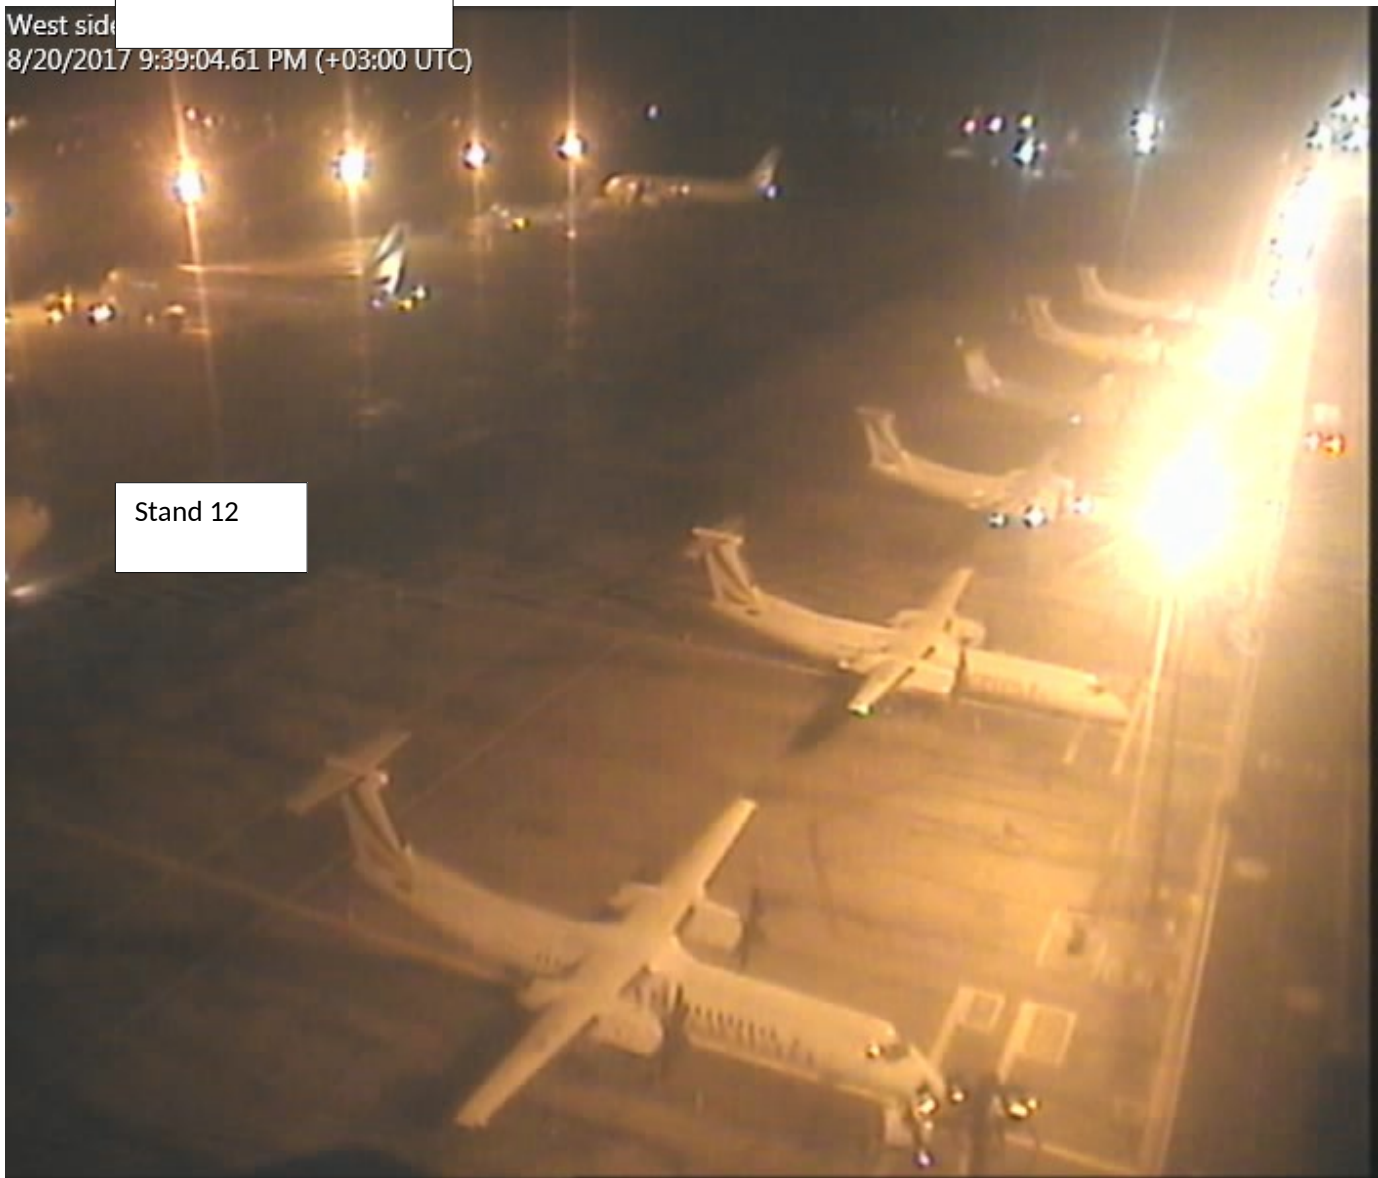
Air bus on stop  
position already

Stand 15

Boeing crossed stand 12

Stand 12

While the Air Bus was already in the stop position, the Boeing B777 was passing abeam stand 22.

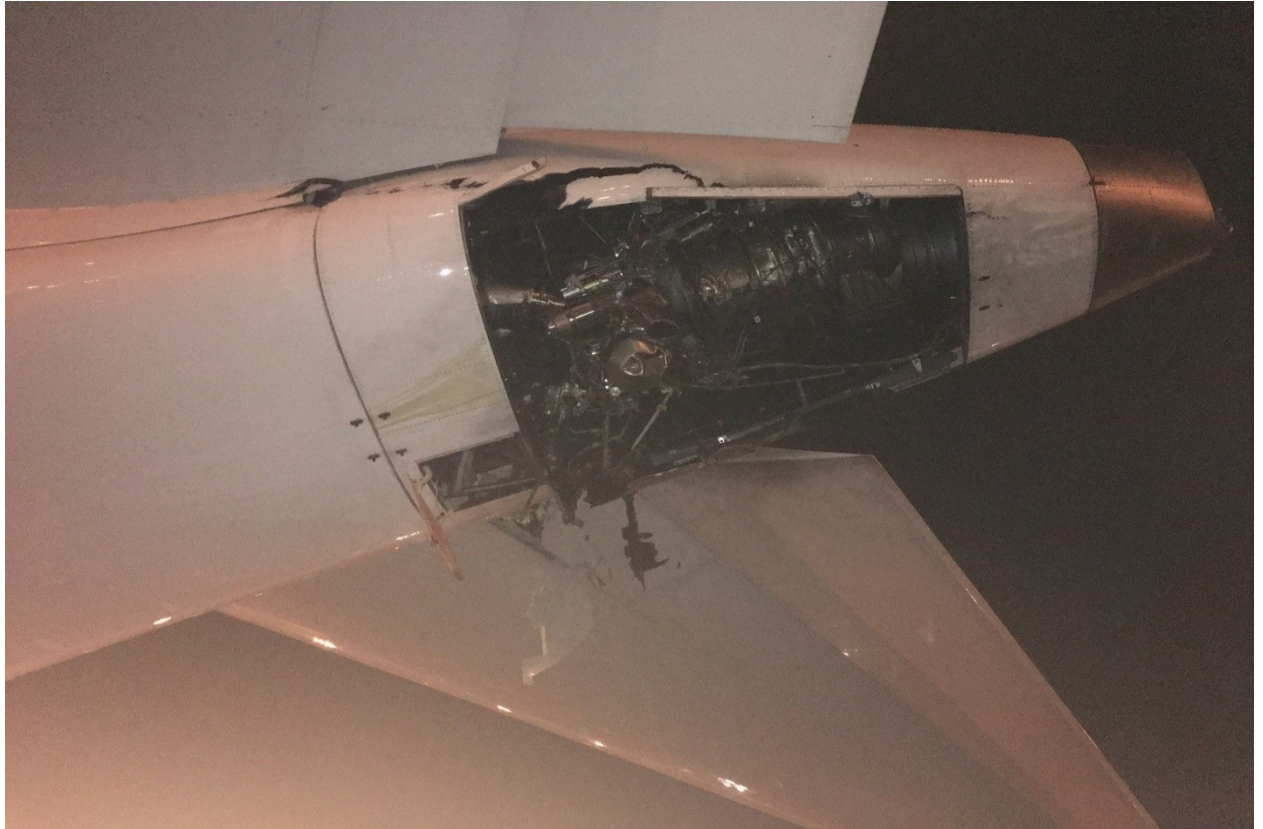
### 1.3.1 ET-ATR, Airbus A350-900

Tail cone seriously damaged, left and right horizontal stabilizer lower skin scratched and gouged, right elevator inboard lower surface damaged, right horizontal stabilizer access panel at inboard lower surface damaged, right horizontal stabilizer fuselage AFT fairing access panel damaged, APU seriously damaged, APU fire extinguisher damaged, APU fuel shroud damaged, APU bleed duct damaged.

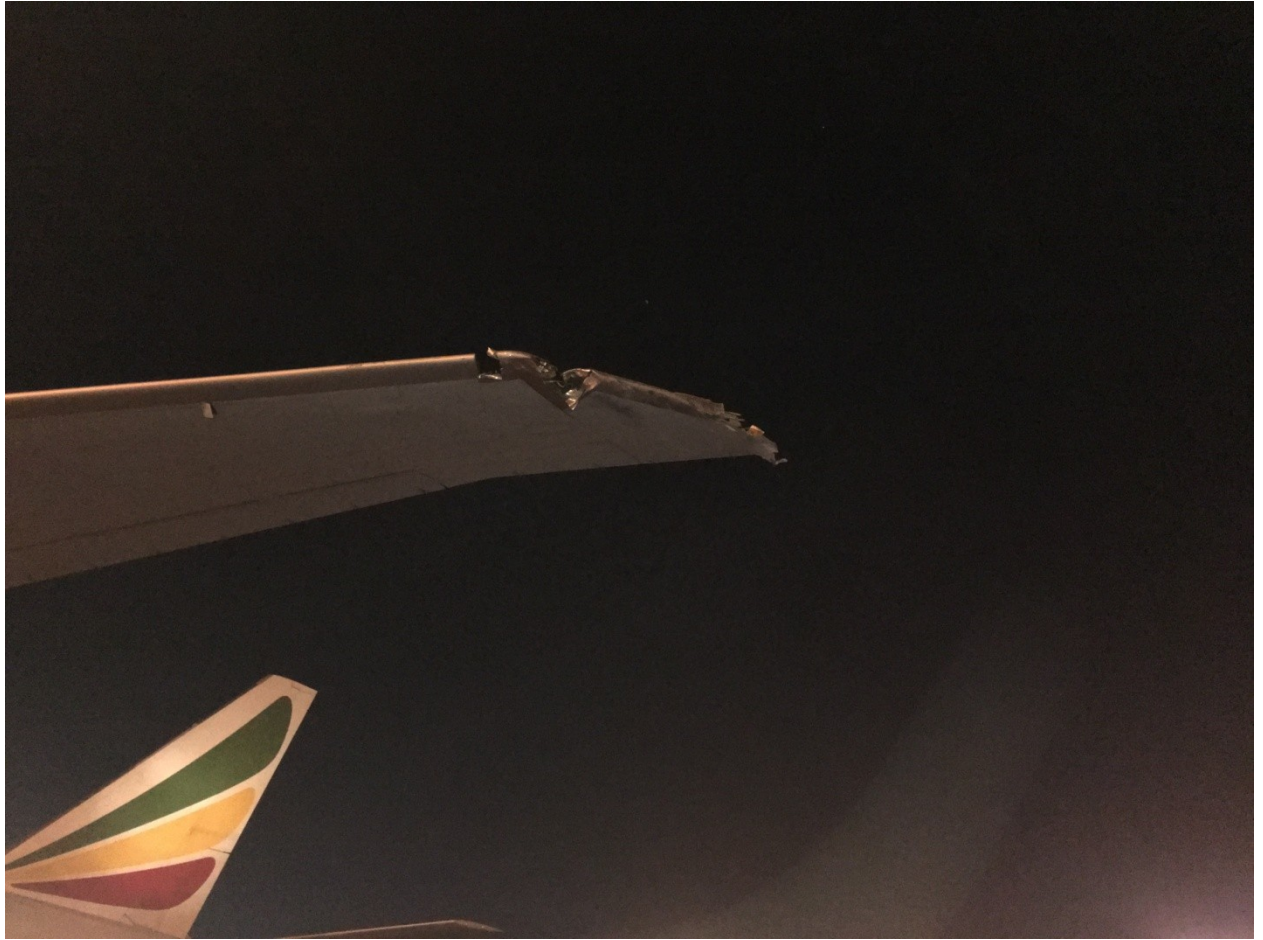
### **1.3.2 ET-AQL B777-200R**

Left wing raked wing tip assembly damaged, left wing leading edge slat damaged, left wing fixed leading edge under leading edge slat damaged, left wing upper fixed leading edge slice strap bent torn and cracked, left wing lower skin panel wing extension deformed, left wing web rear spar assembly deformed, left wing two vortex generators damaged, left wing outboard aileron outboard edge area cracked and gouged, left wing rib assembly fixed leading edge assembly torn, cracked, and developed multiple gouges.

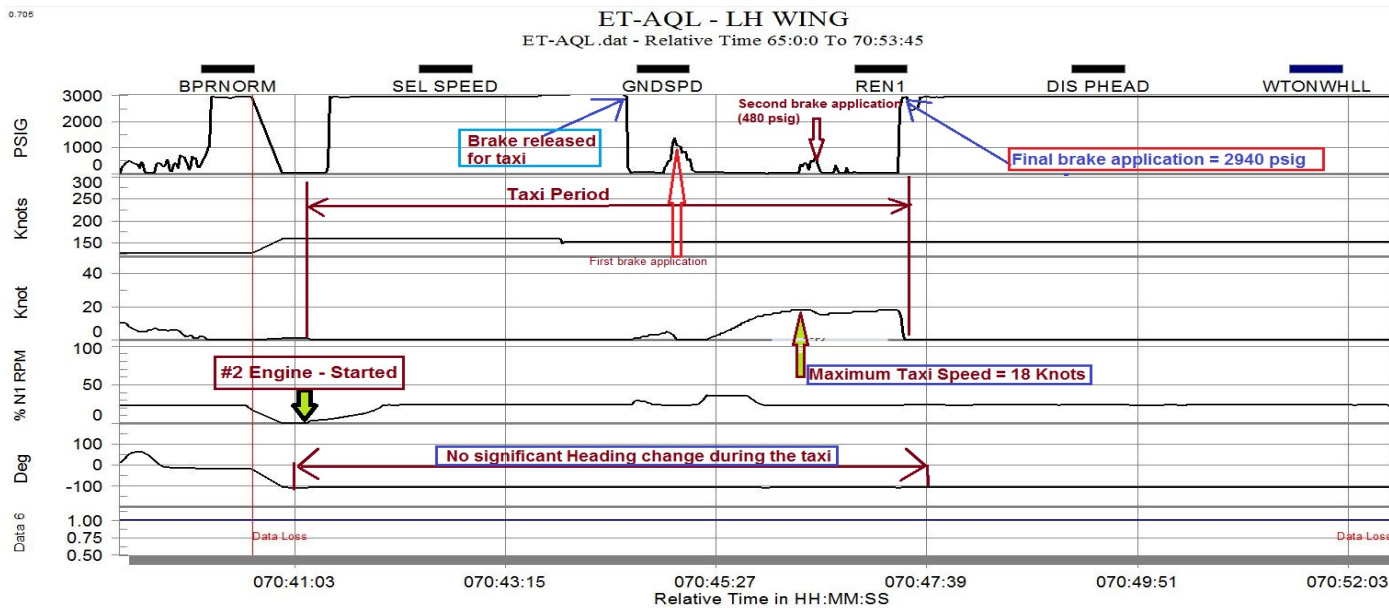
- Engine started for taxi with heading – 108.5, @ 18:25:53
- Brake fully Released for taxi @ 18:29:14
- First brake applied and released at 18:29:35 after 21 seconds of brake fully released.
- Final taxi start (A/C started to build up taxi speed) 18:30:03
- Maximum taxi speed of the period attained 18 Knots @18:30:54
- Second brake application trial at (maximum brake pressure 480 psi, and at taxi speed 18 Knots) 18:31:06
- Final full brake application of 2,984 psi @18:32:02 (also at max taxi speed of 18 knots), heading -109.0
